Observations and Recommendations Regarding Landslide Hazards Related to the January 13, 2001 M-7.6 El Salvador Earthquake

**Open-File Report 01-141
On-line Edition**

**U.S. Department of the Interior
U.S. Geological Survey**

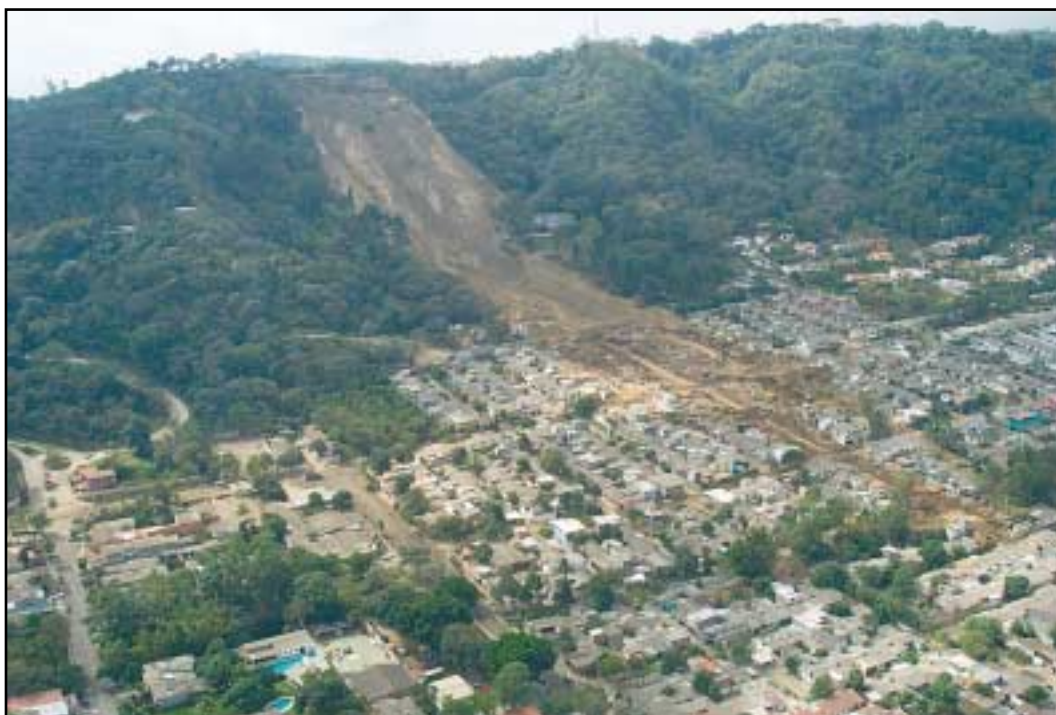
The January 13 earthquake triggered the Las Colinas landslide off the steep northern flank of Balsamo Ridge (fig.1). The landslide—a rapid

Figure 1. Las Colinas landslide. (Photo by E.L. Harp, USGS)

0.7 g, which is a very high level of shaking at this distance from the epicenter (>100 km), but shaking on the ridge top appears to have been greater still. This exceptionally strong shaking, along with the presence of thick, loose to poorly consolidated, young volcanic deposits, the steep topography on the northern flank of Balsamo Ridge, and possibly the presence of a relatively impermeable ancient soil at the top of the Balsamo Formation were contributing factors to the triggering of the Las Colinas landslide.

Recommendations: The following recommendations were delivered to the Ministerio de Medio Ambiente y Recursos Naturales:

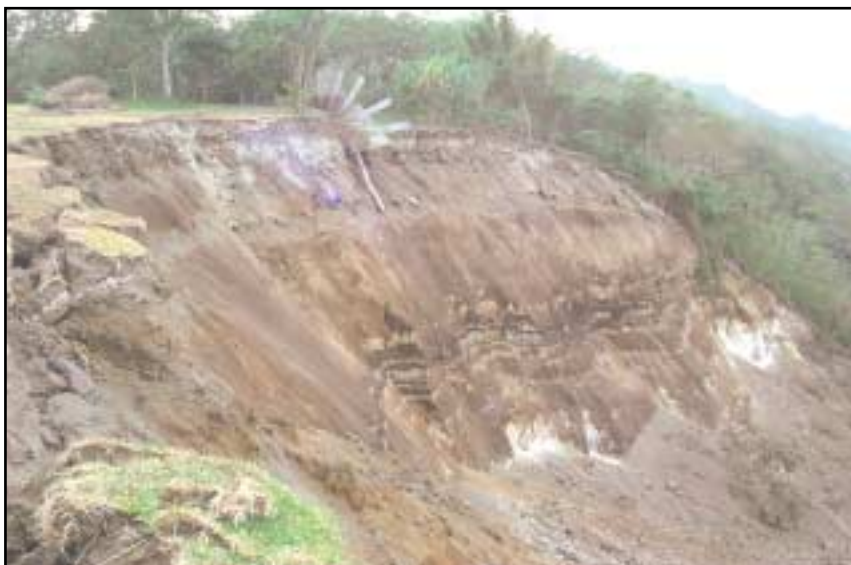
Figure 2. Head scarp of Las Colinas landslide (view to south-west). The whitish layer in the lower right part of the photo is the TB4 tephra. (Photo by E.L. Harp, USGS)

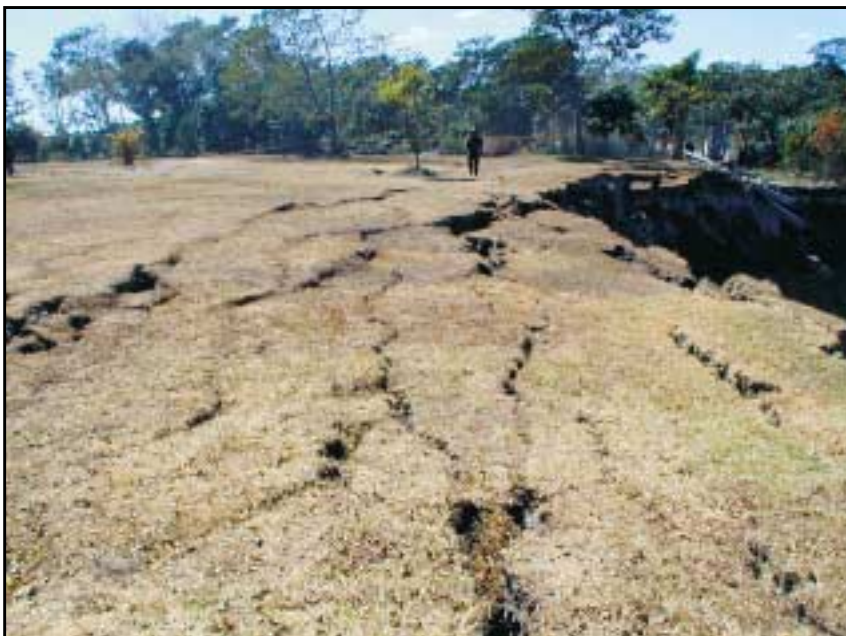
and (2) landslides that could be triggered by future large earthquakes similar to that of January 13. Landslides likely to be triggered by aftershocks or during the rainy season are likely to be much smaller than the Las Colinas slide. Cracks are present all along the crest of Balsamo Ridge, but they bound relatively small masses of earth that, if they fail, may not reach the base of the slope and are unlikely to move far

beyond the base of the slope (fig. 3). Also, loose landslide material still remains in the Las Colinas landslide scar that could move when the rains start, but the volume of this material is small enough that it is unlikely to travel far from the slope base. The potential for large slides in future large earthquakes is more difficult to define and will require detailed study, as outlined below. Listed below is a prioritized list of actions that should be taken to mitigate landslide hazards along the base of Balsamo Ridge:

Figure 3. Cracks above head scarp of Las Colinas landslide.

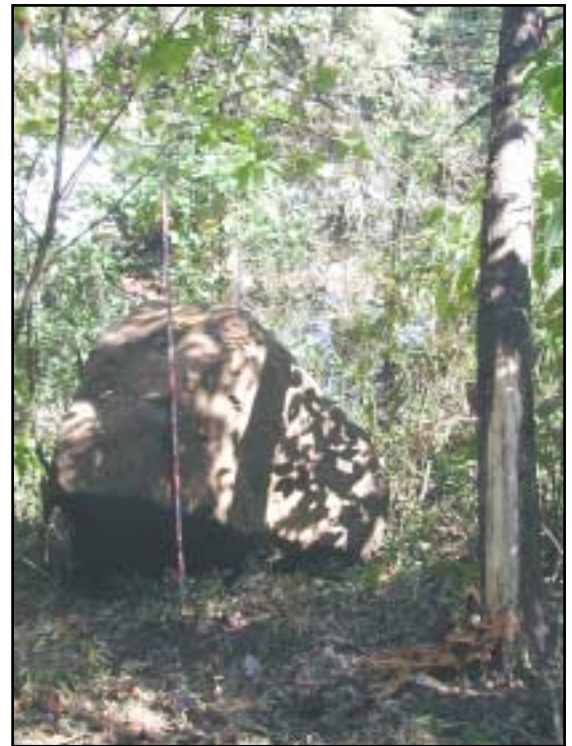
Figure 5. Boulder shaken loose by January 17 earthquake that came to rest near houses in Santa Elena. The measuring stick is 2 meters long. Note the scars on the tree at the right where the boulder tore the bark off the trunk.

cascade down the 30-40° slope at high enough speed to bounce and become airborne. Several such boulders are strewn throughout the forest all the way to the base of the slope, indicating that this process has been occurring for some time. During the recent M-7.6 earthquake, a 5-m³ boulder released from the outcrop (see fig. 4) and moved downslope rapidly enough to knock down a 0.5-m-diameter tree and stop within 30 m

of houses at the base of the slope (fig. 5). Had this boulder continued downslope, it would have severely damaged any structure it hit. The hazard from rock falls is greatest along the western end of the ridge and lessens somewhat eastward as the rock-fall sources are higher on the slope in that direction (boulders released higher on the slope are more likely to be slowed and stopped by the thick forest covering the slope). Although heavy rainfall could also trigger rock falls in this area, the greatest hazard is probably from rocks shaken loose in future earthquakes. Houses in this area are built at the base of the slope, and houses in the uppermost part of this neighborhood face the greatest risk.

Recommendations: Several methods exist for mitigating rock-fall hazards. At the rock-fall source, loose boulders can be bolted into

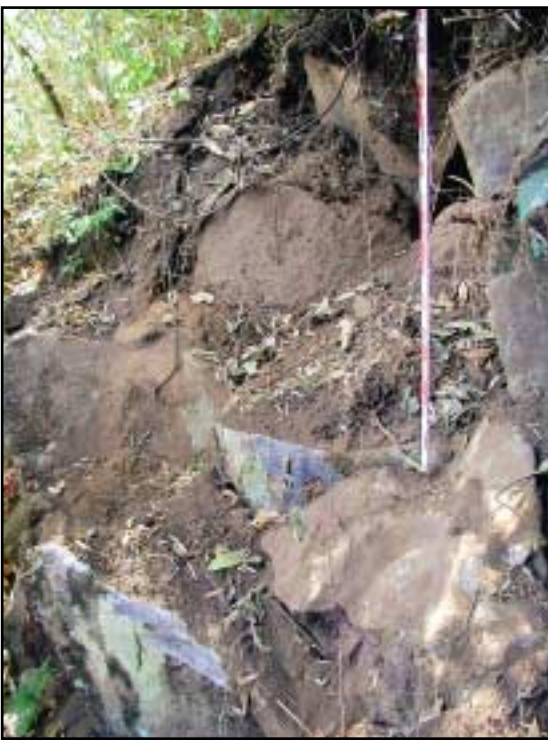
Situation: A steep ridge extends along the southwest edge of Santa Elena. Massive, hard lava flows crop out on the upper part of this ridge, and these rock outcrops produced rock falls during the earthquake. Fractures in the rock outcrops create rock blocks 1-20 m³ in volume (fig. 4) that can be shaken loose by earthquake shaking; the blocks then

Figure 4. Rock-fall source on ridge above Santa Elena. The boulder shown in Figure 5 came from this source.

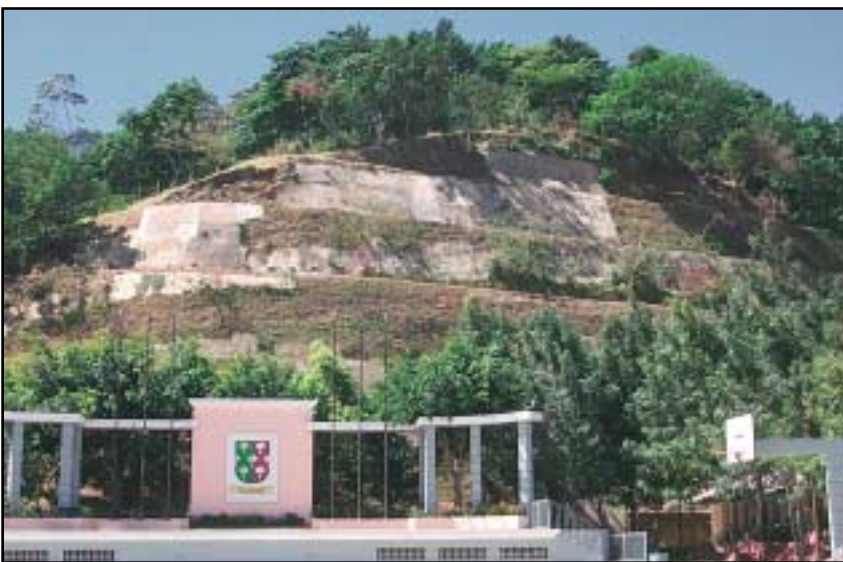
Situation: The La Floresta school for girls has been evacuated since the M-7.6 earthquake because of structural concerns as well as concerns about the stability of the cut slope behind the school. The school is built at the foot of a cut slope that is about 40 m high with an average slope of about 60° (fig. 6). The slope is benched; benches are about 2 m wide with culvert drains and are separated by 60-70° risers that are

Figure 6. Cut slope above La Floresta school for girls. Scar on upper left part of slope is a small landslide triggered by the January 13 earthquake.

Recommendations: The material on the top tier of the cut slope that failed during the earthquake needs to be removed and the cracks sealed before the rainy season begins to prevent mobilization of the failed material, which could move rapidly downs-

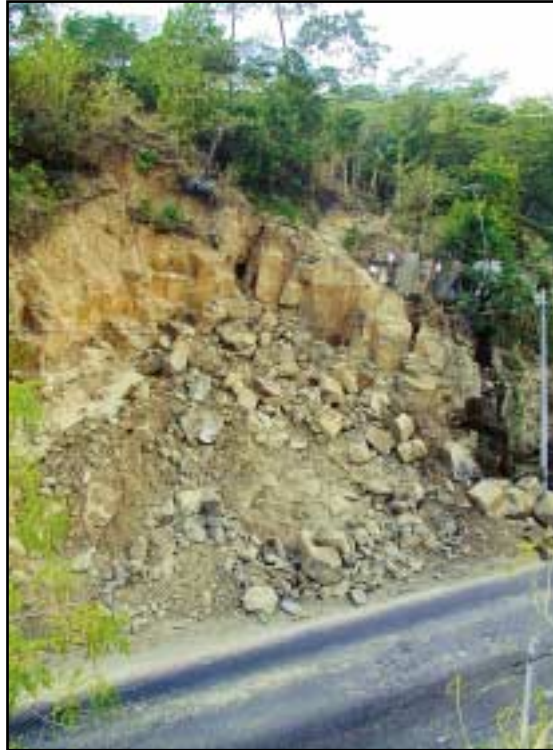
Situation: The earthquake triggered a rock fall having a volume of about 2,500 m³ from the road cut at this location (fig. 7). One house was

Figure 7. Rock fall between Zaragoza and El Transito.

destroyed in the initial rock fall. Several additional houses are located along the new rock-fall scarp. The rock mass below these houses is fractured and dilated and is at great risk of failing in aftershocks, heavy rainfall, or future large earthquakes (fig. 8). This poses risks to both the residents of the houses and motorists on the road below.

Recommendations: Houses along the fresh scarp should be removed immediately and the residents relocated. Rock-fall material from the earthquake should be removed from the landslide scar, and the rock face should be graded back to a more stable slope angle.

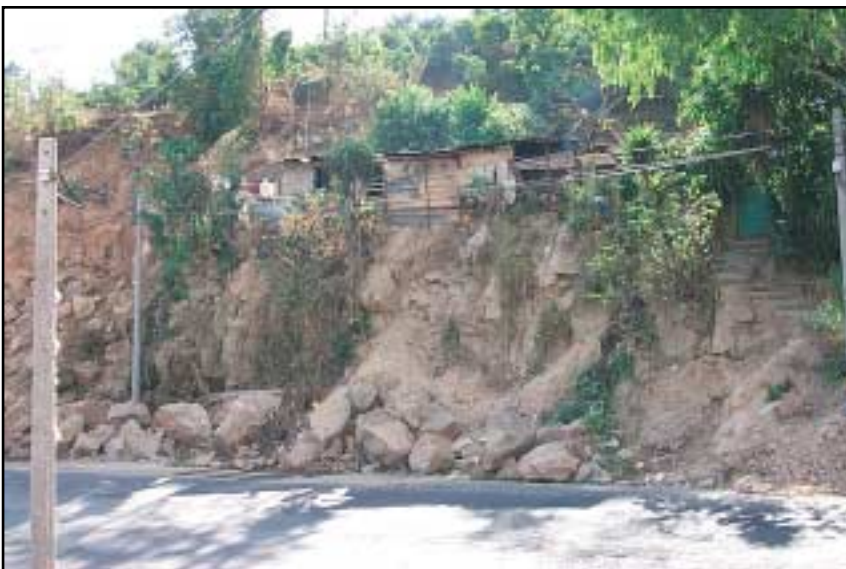
Figure 8. Houses along rock-fall scarp between Zaragoza and El Transito.

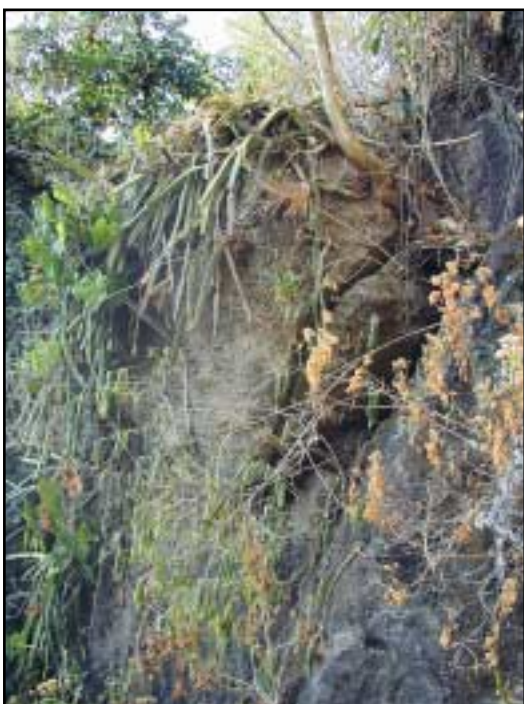
Situation: Several houses are located below and near vertical rock faces that produced rock falls during the earthquake. The faces are moderately fractured and could produce future rock falls during earthquakes or intense rainfall. The face on the east end of this area is particularly hazardous and has a large (10 m³) boulder that is detached and ready to fall (fig. 9). Several houses are directly in the path of this boulder.

Figure 9. Precariously perched boulder above houses in Santa Teresita.

Removal of the precariously perched boulder from the eastern rock face would be the most effective course. This will require attaching cables to the rock and either pulling it to the top of the slope with heavy equipment or causing it to fall with restraints so that it will not continue into the houses below. Cable fences to catch boulders could be installed in other

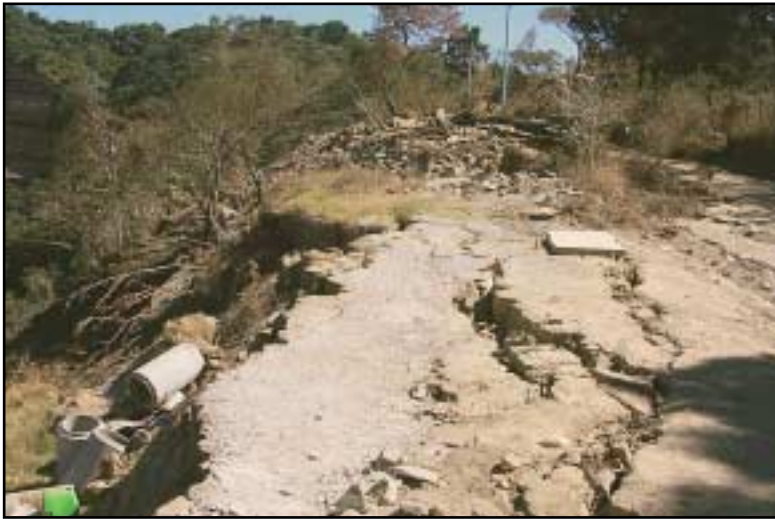
Situation: Almost the entire length of the road extends along a narrow, steep-sided ridge. The ridge experienced amplified ground shaking and is thoroughly shattered along most of its length (fig. 10). The ground surface is fissured and shattered, road cuts have failed continuously, and nearly all structures have collapsed. The road is in very poor condition—it is covered by as much as 0.5 m of fine, powdery dust, and the failed road cuts are depositing more material on the road (fig. 11). When this material gets wet in the rainy season, the road is likely to be impassable. On the east end, the road traverses a large, deep debris slide triggered by the earthquake that is similar to the Las Colinas landslide.

Figure 10. Shattered ridge near Comasagua.

Recommendations: The road cuts should be stabilized by regrading and removing failed material. The road itself needs to be regraded to remove the thick layer of dust; it should then be graded with gravel or other aggregate to provide stability to the road base. This needs to occur before the rainy season if the road is to remain open. Keeping the road open across the large landslide at the east end may be very difficult. It may require building retaining walls above the road to catch additional landslide material that is likely to fall from the scarp area.

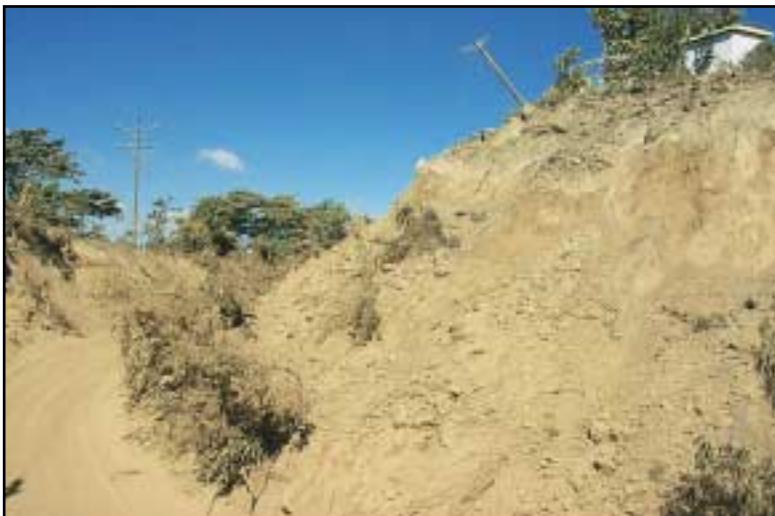
Figure 11. Road-cut failures on road from Las Delicias to Comasagua.

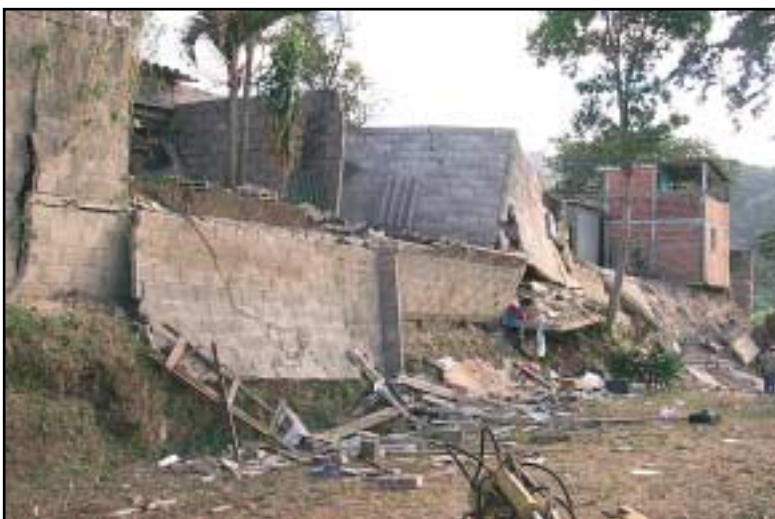
Figure 12. Damage from strong shaking and landsliding at Alpes Suizos.

Situation: Several houses built on the edge of the slope overlooking the highway were severely damaged during the earthquake by a combination of strong shaking and failure of the slope beneath the houses (fig. 12). The rear half of the houses detached in many cases and moved several centimeters toward the slope. Houses across the street to the east also had serious cracking and damage but not as severe. The area is currently evacuated, and many residents are eager to repair and rebuild their homes.

Recommendations: The likelihood of continuing slope movement is high, both in earthquakes and rainfall, and the slope movement will be difficult to stabilize economically and reliably. The cost of slope stabilization will likely be much greater than the value of the affected houses; therefore, the houses on the outer edge of the slope should be condemned and removed rather than repaired. The houses on the east side of the street could be repaired and salvaged if a detailed study indicated that the slope failure will not extend that far behind the edge of the slope.

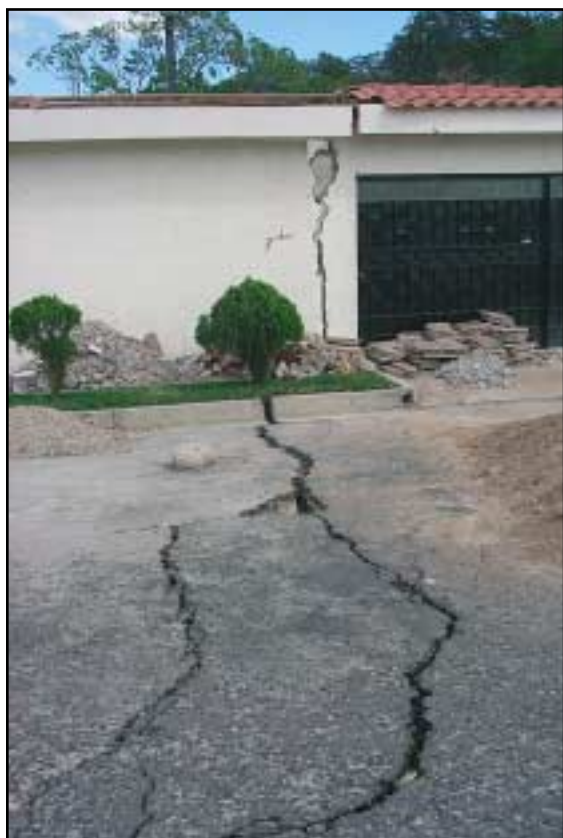
Situation: Cracks as wide as 10 cm opened during the earthquake. The cracks separate road pavement and extend through several houses, causing serious damage (fig. 13). The cracks appear to occur near the boundary of the cut slope and the fill slope, a situation that has been observed in earthquakes elsewhere. Renewed cracking in future earthquakes is likely, and failure of the edge of the fill during the rainy season is possible.

Figure 13. Cracks along the edge of a fill slope at La Cima 3.

Recommendations: Cracks should be carefully filled and sealed before the rains begin. Homeowners should be informed that renewed cracking is likely in future earthquakes and rainy seasons. A detailed geotechnical study should be conducted to determine the stability of the edge of the fill in the rainy season. Homes below

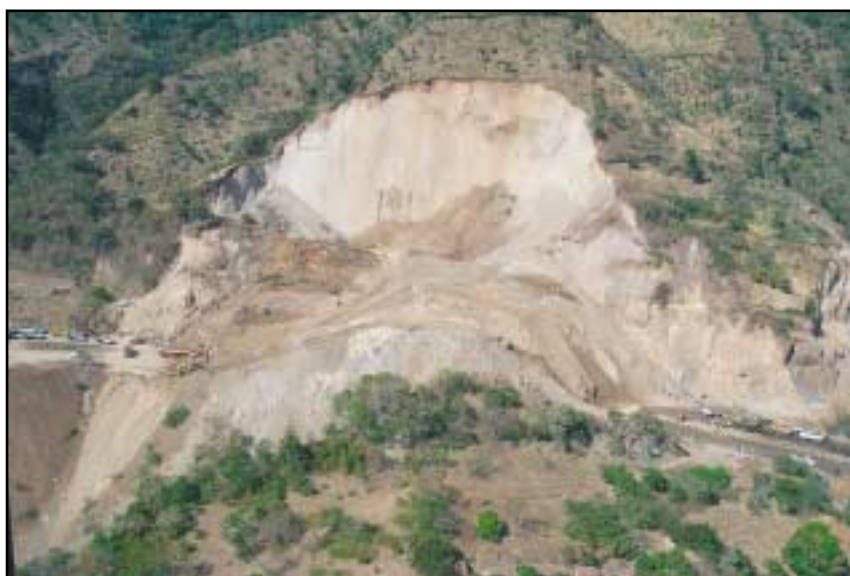
Situation: The earthquake triggered a massive debris slide from a road cut on the Pan-American Highway (fig. 14). The slide is approximately 250 m wide at its base, 120 m high, and 25 m thick, which yields an estimated volume of 500,000-700,000 m³. The main scarp of the landslide formed along the surface of a south-dipping normal fault, which created a zone of weakened, sheared material

Figure 14. Landslide blocking the Pan-American Highway near San Vicente. (Photo by E.L. Harp, USGS)

that facilitated slope failure during the earthquake shaking. Excavation of the landslide deposit from the road was almost complete as of February 7, 2001. Local residents stated that the road cut had been oversteepened by people excavating rocks from the cut to sell as building aggregate. We inspected the slope above the crown of the landslide and saw no open cracks or other indications of impending failure of material above the scarp, but near-vertical scarps in weak material commonly retreat through time, so small landslides from the scarp should be expected; most of these will come to rest on the remaining landslide deposit that is above the road. Landslide material removed from the roadway was dumped over the edge of the slope below the road. This uncompacted fill slope is highly susceptible to failure during rainy periods or future earthquakes, which could endanger homes downslope.

Recommendations: Water will tend to collect on top of the remaining landslide deposit, which is above the highway. A drainage system should be installed to keep as much water as possible from the top of the landslide material. The cut slope above the road in the landslide material is rather steep and can be expected to produce small- to moderate-size landslides that could close the road and endanger motorists in rain storms or moderate to large earthquakes; therefore, this cut may need to be laid back to a gentler slope angle. The waste slope below the road will be diffi-

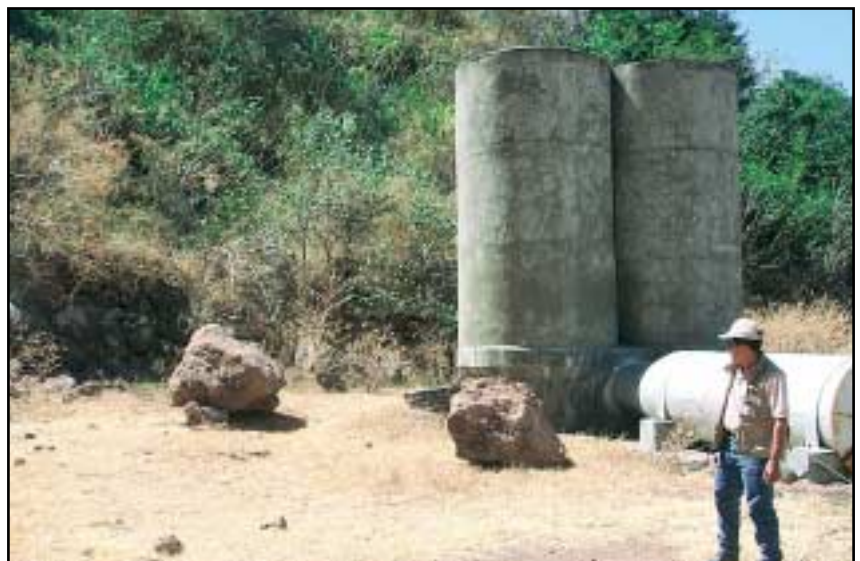
Situation: A rock fall of several hundred cubic meters occurred on the steep slope behind the well; the slope is the scarp of an older, larger landslide. Several boulders from the rock fall stopped within a few meters of the well equipment; the biggest single boulder is about 5 m³ (fig. 15). Another landslide heads just below the road to the well. The road itself has cracks parallel to the edge of the slope.

Figure 15. Boulders from rock fall above geothermal well near Berlin.

Recommendations: More boulders are likely to come off the slope above the well in future earthquakes and heavy rain storms. The best solution may be to construct a cable fence to catch and stop the boulders at the base of the slope. The fence will need to be designed by a qualified rock engineer and constructed to specifications if it is to perform properly.

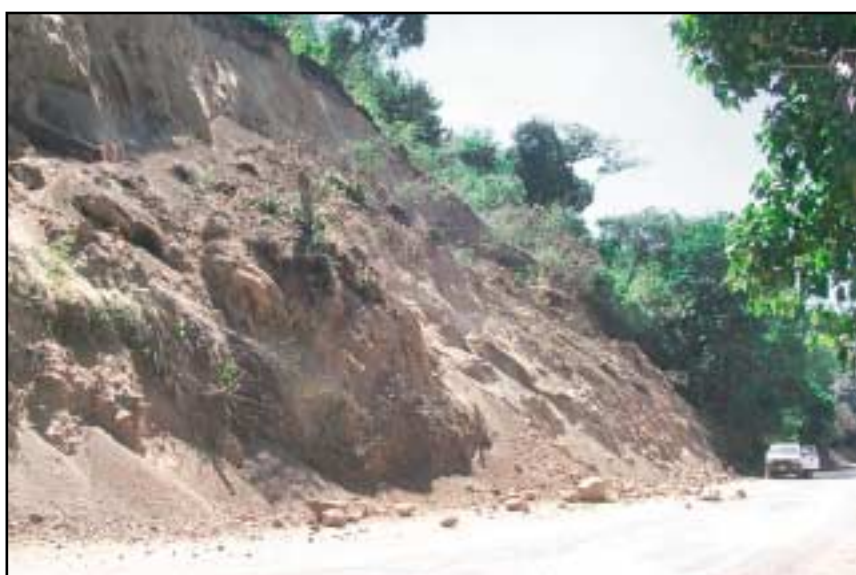
Situation: The earthquake triggered many rock falls along the road having volumes as great as to several hundred cubic meters. The largest of these (at the coordinates given above) is particularly hazardous (fig. 18). Many dilated fractures have openings of 10 cm or more. Many boulders are precariously perched and ready to fall. Modest rainfall or earthquake shaking will bring down more material unless immediate remedial work is undertaken

Figure 16. Landslide on road from Berlin to Alegria.

Recommendations: The road cut needs to be stabilized by removing loose boulders and perhaps using additional rock engineering measures to stabilize the rocks.

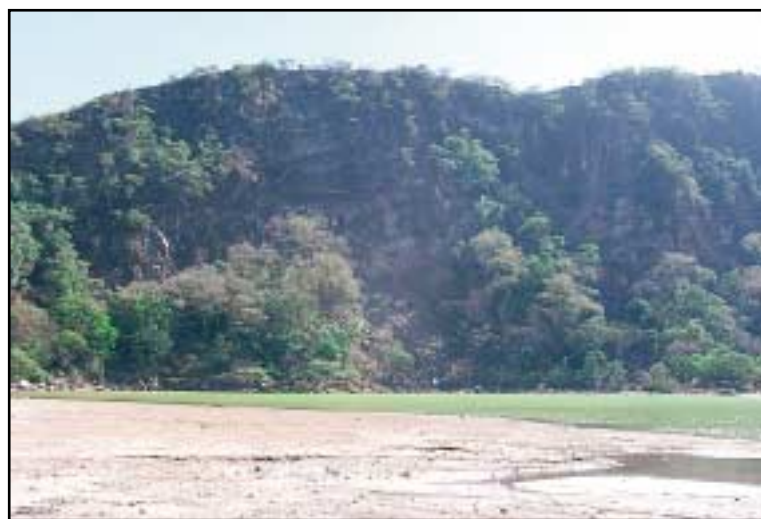
Figure 17. Rock falls from slopes surrounding Laguna Alegria.

Recommendations: Clear the road of rock-fall debris and be prepared for future rock falls. Post signs warning visitors of the possibility of rock falls.

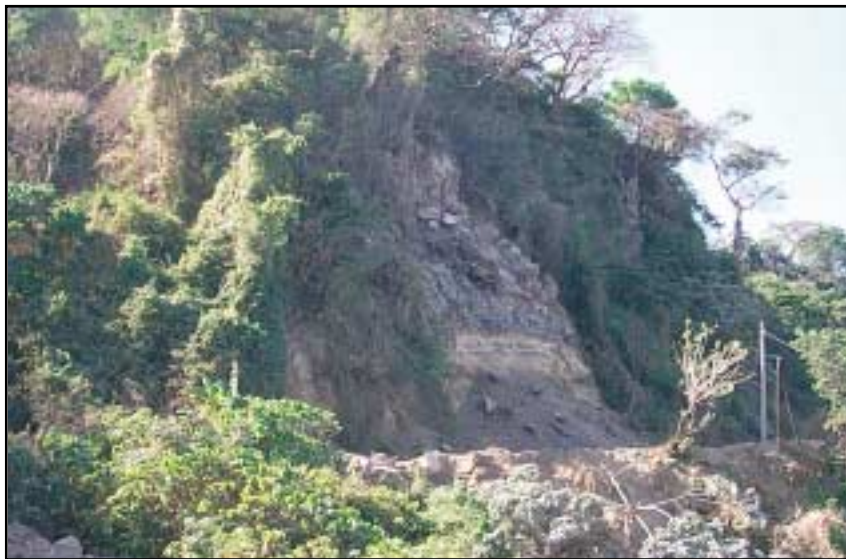
Figure 18. Rock fall on road from Alegria to Santiago de María.

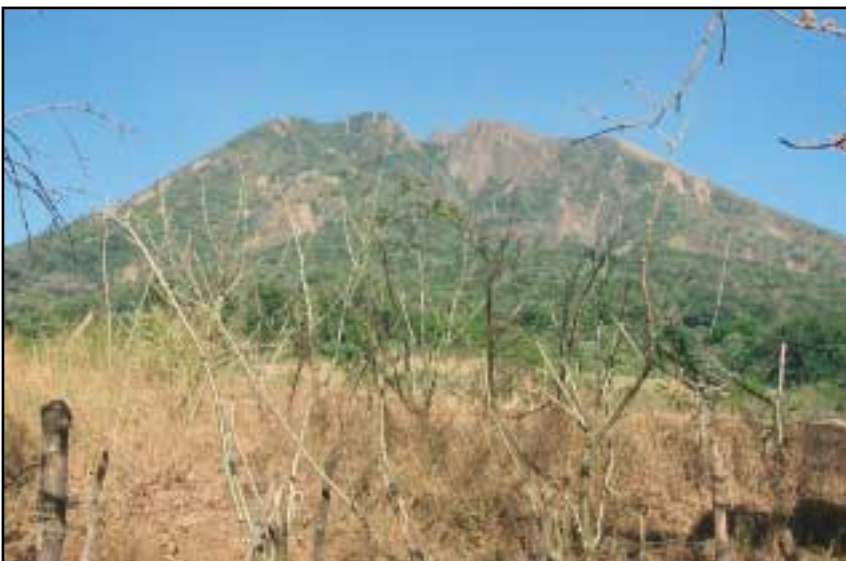
Situation: Many large landslides occurred on the flanks of Usulután Volcano (fig. 19). They probably affect only the coffee plantations on the slopes, but sediment from these land-

Figure 19. Landslides from the flanks of Usulután volcano.

slide deposits will wash into drainages over time and could cause sedimentation problems downstream.

Recommendations: Plantation owners should address landslide problems. Communities downstream from the flanks of the volcano should be warned of possible sedimentation issues in the future.

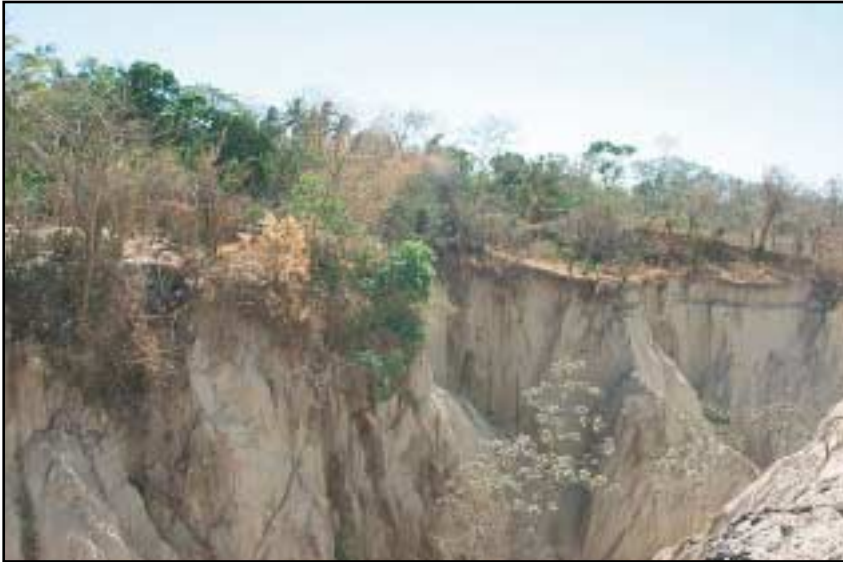
Situation: This town is built on a very thick layer of white, powdery volcanic tephra. Deep gorges have been eroded into the ash deposits on the edge of town. These gorges have nearly vertical walls 70-80 m high and are about 50 m or more wide. The earthquake triggered massive failures along the walls of the gorges; blocks and slabs of material hundreds to thousands of cubic meters in volume cascaded to the base of the very steep slopes (fig. 20). Numerous cracks and fissures parallel to the edge of the gorge and as far as 30 m from the edge define additional slabs of material that are likely to fail in the rainy season or in future earthquakes. The head of one gorge is already undermining the edge of a street in the town, and headward erosion will undermine this street until it is

Figure 20. Failures of near-vertical slopes in San Pedro Masahuat.

impassible. The soccer field near town is near the edge of a gorge. Cracks extend across the length of the field parallel to the edge of the bluff. The cracks have 1-3 cm of displacement downward and toward the bluff edge. These cracks probably define an incipient landslide triggered by the earthquake. This slide is not likely to move catastrophically in the rainy season, but it may experience some additional movement. Future earthquakes are also likely to renew movement at this site.

Recommendations: The ongoing enlargement of the gorges through headward erosion and lateral retreat of the walls is an continuing natural process that cannot be practically or economically controlled. Therefore, residents and local officials need to

accommodate this situation and plan to adapt to the inevitable consequences. The first priority is life safety; therefore, houses very near (within a few meters) the current edge of the gorge need to be removed and the residents relocated. Additionally, houses between large cracks parallel to the edge of the gorge and the edge of the gorge itself may also need to be removed; in such situations, the houses are on a potential landslide block that could fail catastrophically during earthquakes or the rainy season. A thorough investigation of the locations of cracks should be made by carefully inspecting areas along the edge of the bluff and recording houses with nearby cracks. Filling open cracks with dirt or cement will prevent infiltration of water in the rainy season and may delay the failure of new areas outlined by cracks. The second priority is to make a long-term plan to accommodate the retreat of the walls of the gorge. Local officials may want to establish a set-back limit from the edge of the gorge. A limit of about 30 m may be reasonable, but the limit should be set based on the observed distance of earthquake-related cracks from the edge of the bluff. Homes within this 30-m set-back zone would be scheduled for relocation over the next few years as resources are available. This will allow the natural process of bluff recession to occur within a safe zone where no houses exist. The street at the head of the gorge will become impassible soon, and plans should be made immediately to relocate this street.
